Flightfax

ARMY AVIATION
RISK-MANAGEMENT
INFORMATION

JUNE 2003 ♦ VOL. 31 ♦ NO. 6

A Closer Look at FY03 Accidents 4-5

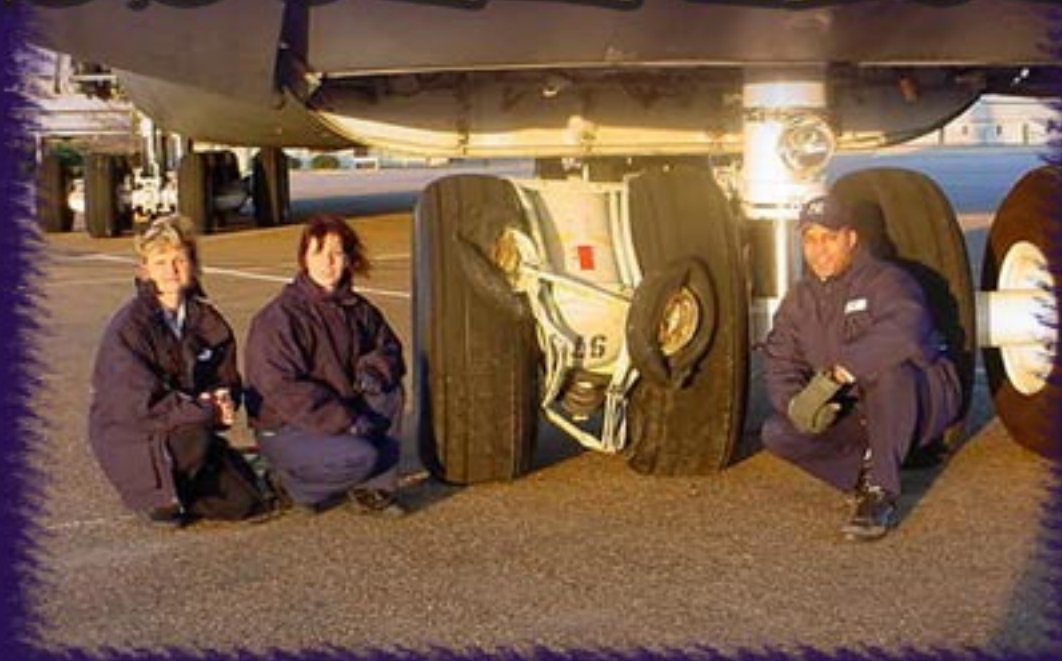
WRONG ASSUMPTION!

A military C-5 was stopped by the efforts of two airline employees. The two employees frantically chased after the C-5 upon noticing it had run over a 100-pound fire extinguisher. The extinguisher was lodged in between the nose gear and sparking as it rolled forward. The crew never realized they had run over the fire extinguisher, but did wonder why there were two crazed women chasing their C-5.
